A Monument of Neglect: Quila Mubarak at Chhachhrauli

Though Qila Mubarak is extra ordinary in its existence, yet it is on the verge of collapse and extinction. The wall paintings here are an example of early art which is also almost extinct. The art of mural painting was present in Punjab, as a way of decorating walls, up to the seventeenth century. At several places popular paintings and drawings were seen as murals or in the form of frescos. The remnants of wall embellishments thus are seen all over Punjab. This current paper is being written with the hope of evaluating methodologies for conserving our structures and our tangible heritage before it is lost forever. A sense of belonging and a sense of ownership must be developed for this feeling and work to evolve. While this is crucial for our heritage it is also important for our National pride.

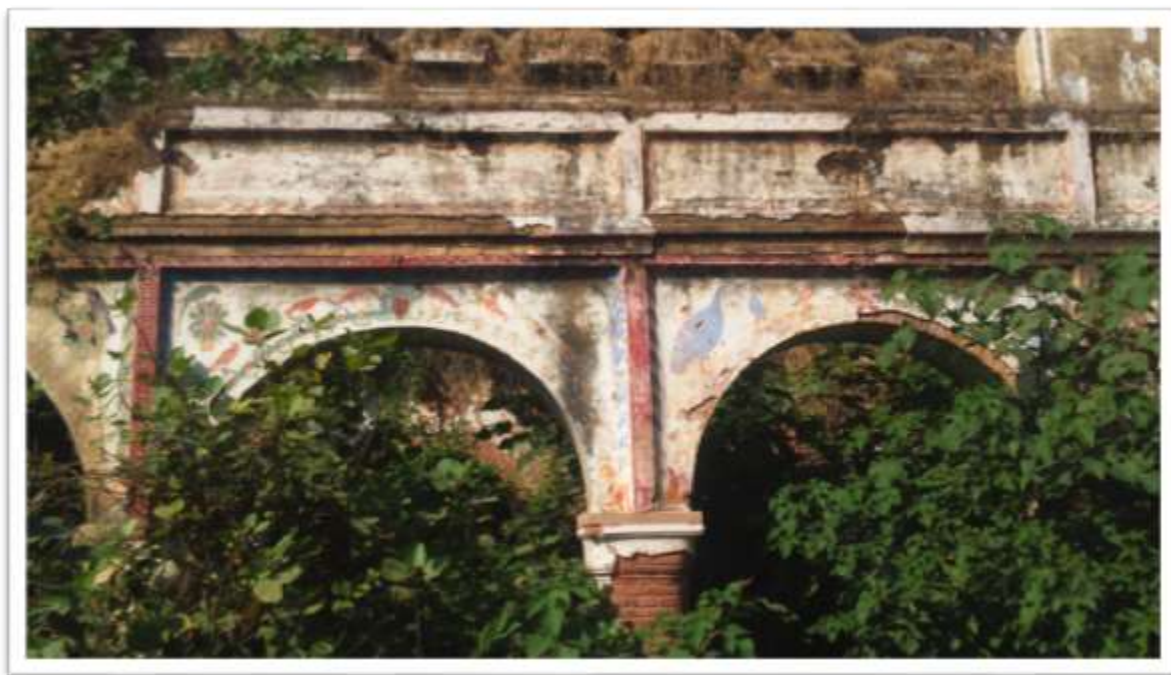
Figure 3 - State of Wall Paintings

Also, major parts of the paintings have been erased or damaged. The roof of the fort has also fallen in places, it is overgrown with foliage and seems to double as a grazing pasture for goats. Human vandalism is rampant with writing on the walls of the Quila. There were faint traces, till not too long ago, of design and colours in the Rang Mahal built in 1630 by Shah Jehan near Jagadhri in district Ambala and that is to be the state of this building unless something is done^{vii}.

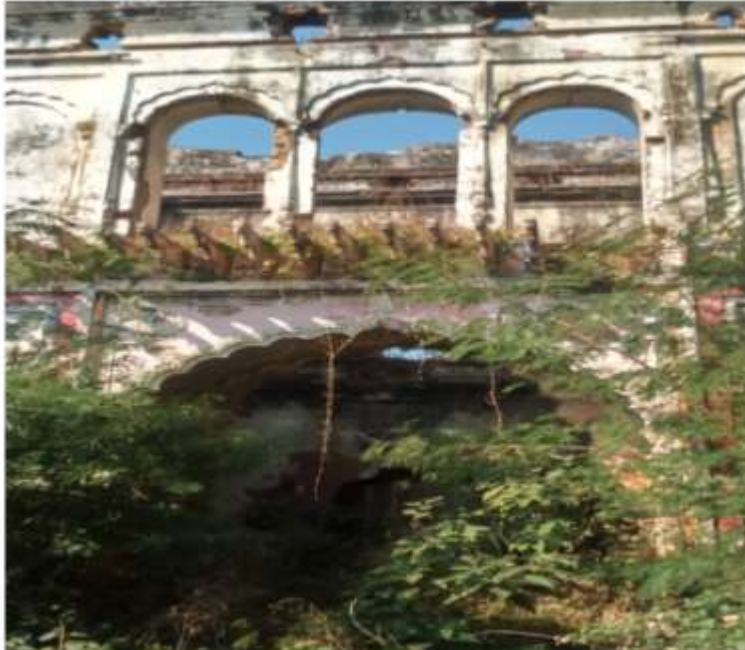
The over grown foliage and vegetation is a cause of concern and water seepage seems to have loosened and disintegrated the bricks of the fort. The fungus and rodents, along with bird dropping and human excreta further intensify the problem. In some areas there is soot as if to signify that at some stage the fort had seen a fire. Manmade disaster, as well as natural ones together have made the fort a total scene of neglect and the art work on the verge of extinction. Wall painting here are a conservation challenge as well as a nightmare so common to all conservation projects around the world. Here they have additional unique problems due to long isolation, as well as socio-economic conditions.

Figure 4 - Decay due to natural vegetation
